# Manhole Inspection Summary

Manhole # S110O1001MH

Insp Date: **5/2/07 1:21 PM**

**Location** Address: **4800 PALMER AVE**

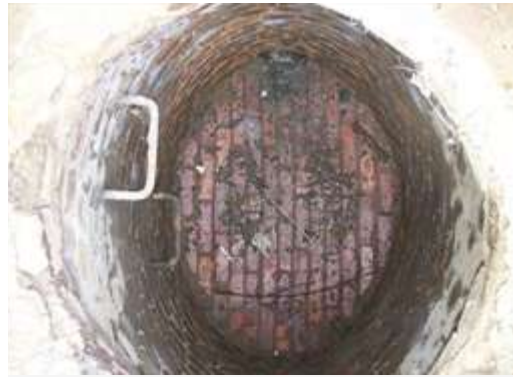
Top View

Condition: **Sound**

Condition: ☒ Sound ☐ Cracked ☐ Leaks

Condition: ☒ Sound ☐ Cracked ☐ Root Intrusion ☐ Loose Brick ☐ Deteriorated

Condition: ☒ Sound ☐ Cracked ☐ Root Intrusion ☐ Deteriorated ☐ Leaks ☐ Debris

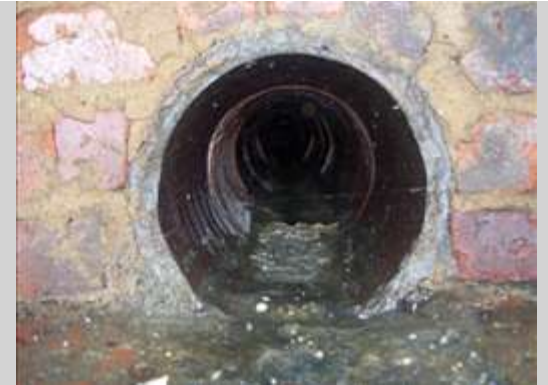
12 O'Clock Outflow

8 in. Circular Gravity Sewer  
Pipe Out @ 12 O'Clock

Pipe Material: **Clay** ☐ Pipe Lined

Deposits: ☐ None ☐ Mud ☒ **Sludge** ☐ Debris ☐ Grease

Silt Depth: **0.25** (in.) Deposits Extent: **Light**

Infiltration: **None** Pipe Seal Cond: **Sound**
